CAFO FACILITY INSPECTION REPORT

03/06/2013
ACTUAL INSPECTION DATE

SD Farms II
FACILITY NAME

REPORT PREPARED BY: Anthony D'Angelo (PG Environmental, LLC) ON 03/19/2013

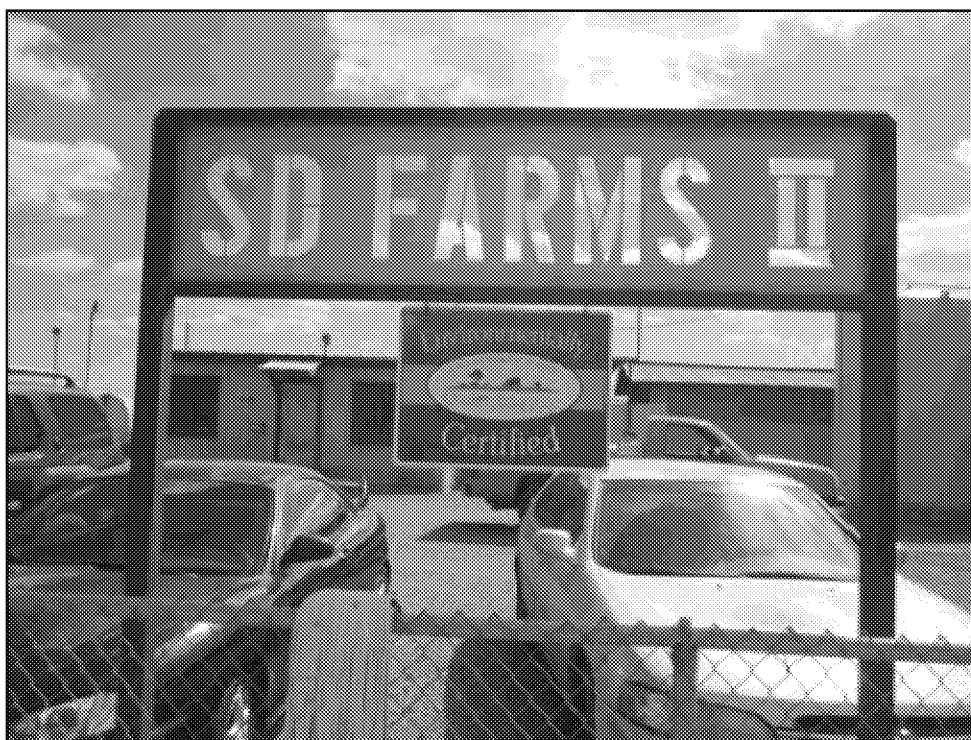
Photograph 1. SD Farms II Facility sign.

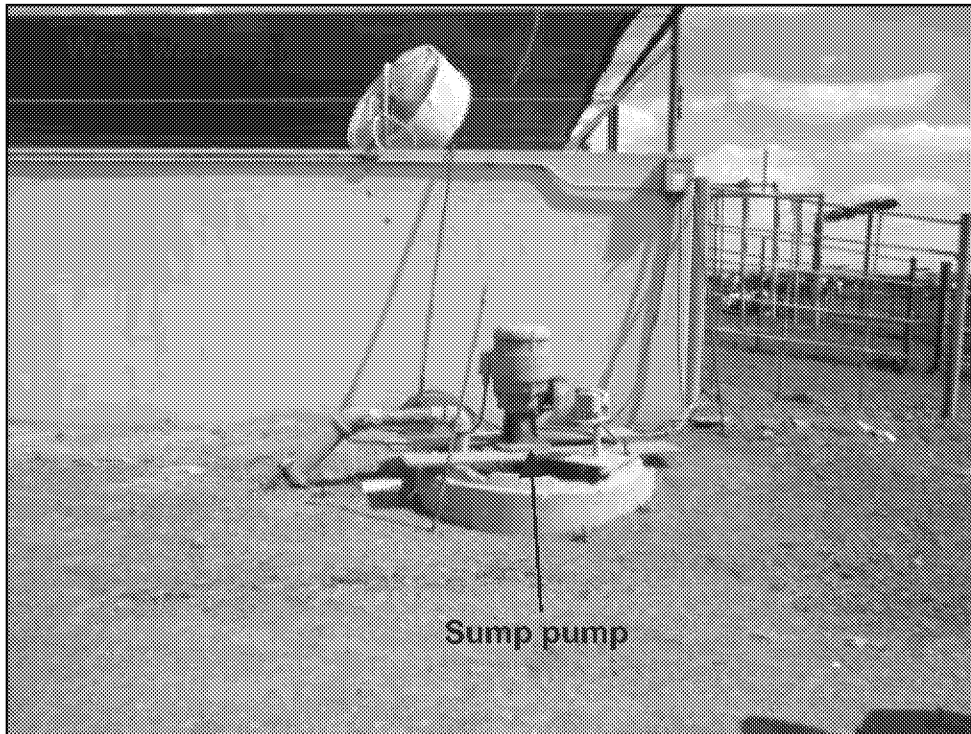
Photograph 2. View facing east of the milking barn process wastewater sump pump located on the west side of the west wash pen. Note the pump conveys process wastewater to Pond A located in the southern portion of the Facility and/or to the disposal pasture located in the northwestern portion of the Facility.

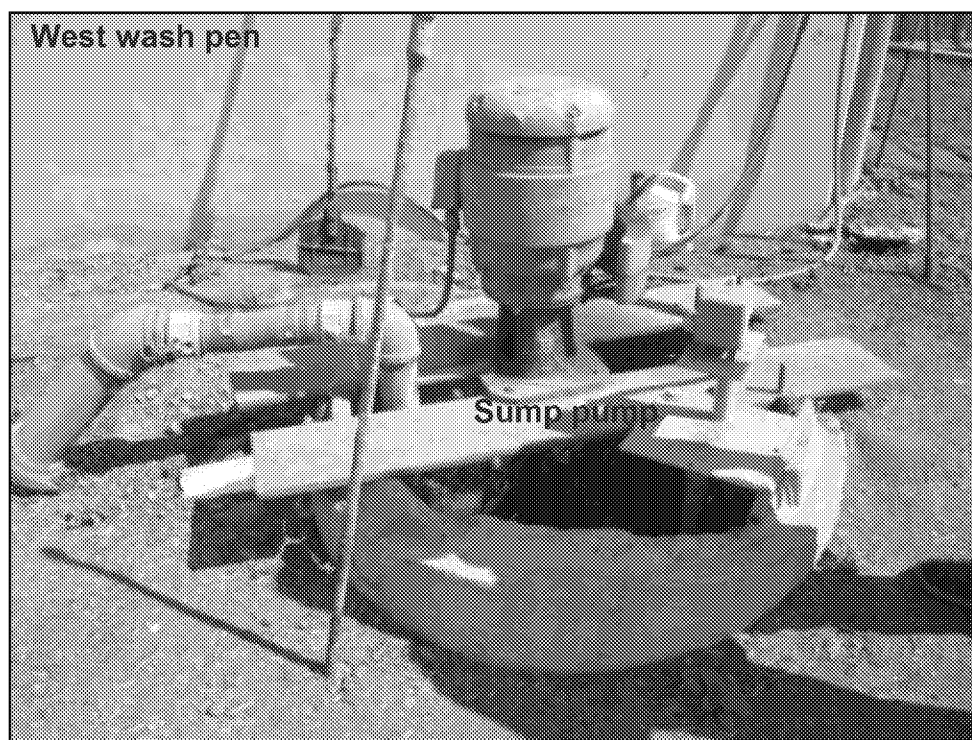
Photograph 3. Additional view of the milking barn process wastewater sump pump shown in Photograph 2.

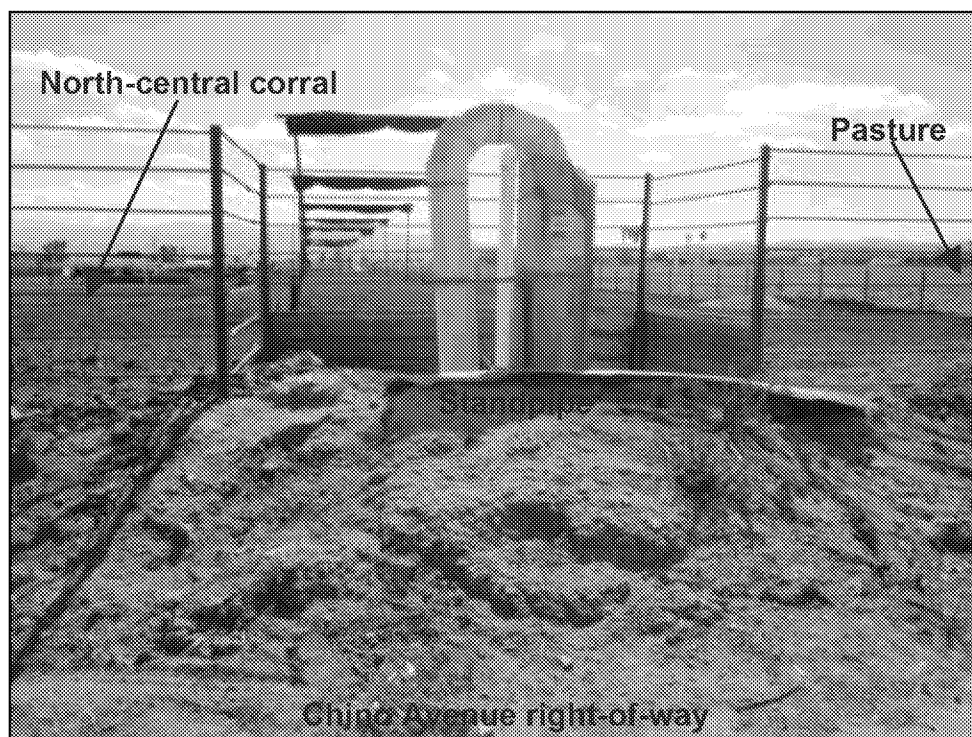
Photograph 4. View facing south of the process wastewater standpipe located on the north side of the north-central corral, adjacent to Chino Avenue.

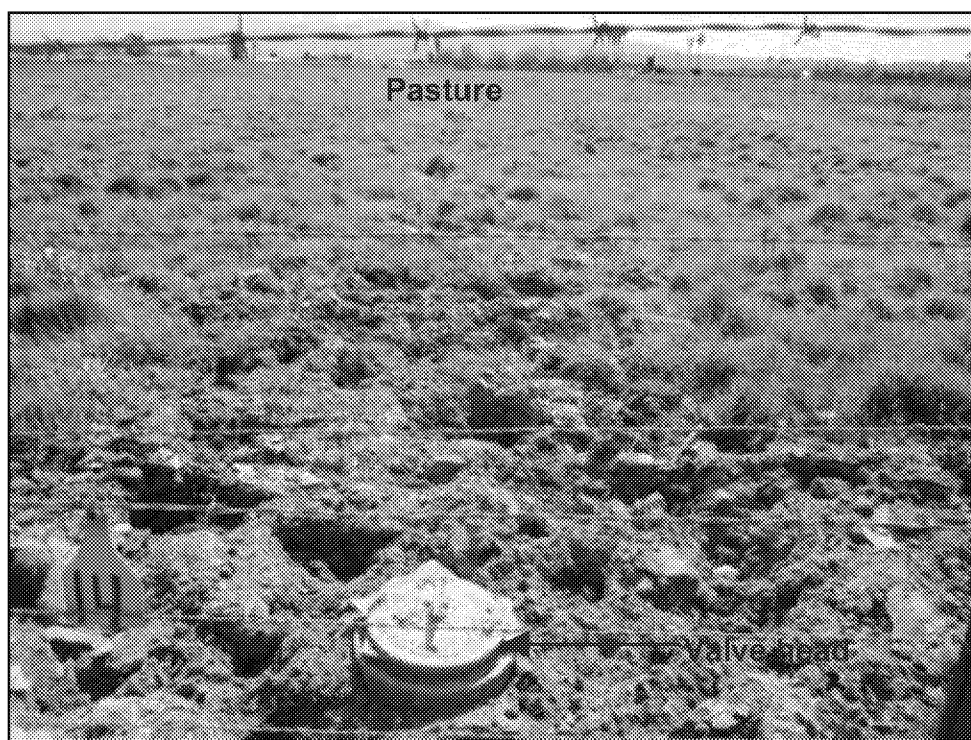
Photograph 5. View facing south of a valve head used for process wastewater land-application disposal located on the north side of the pasture in the northwestern portion of the Facility.

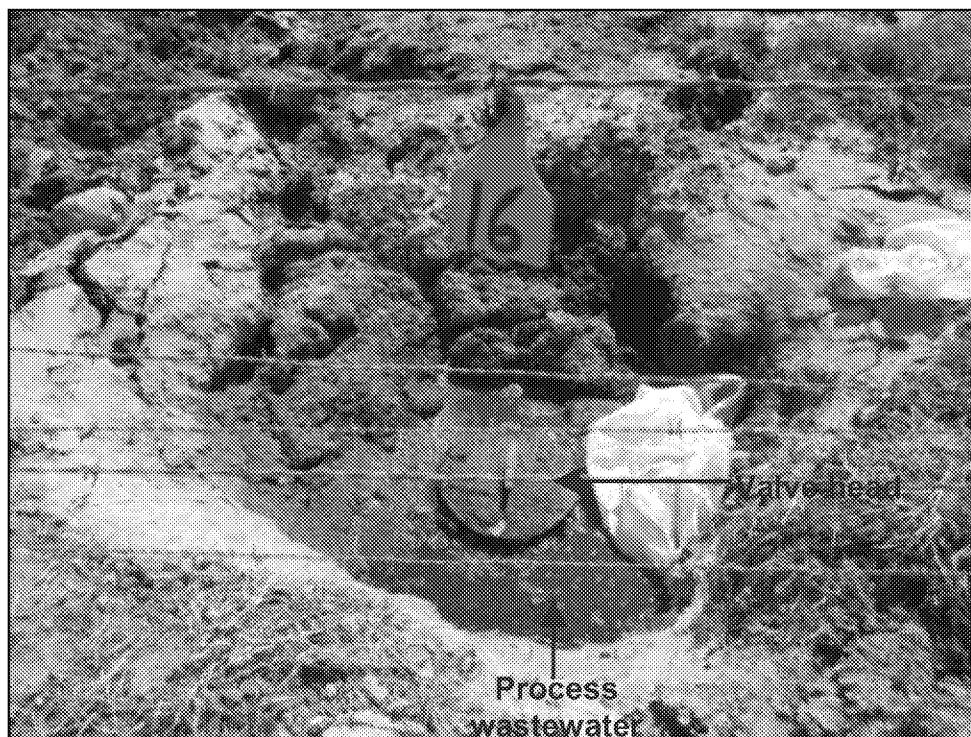
Photograph 6. Close-up view of an active valve head located in the pasture in the northwestern portion of the Facility.

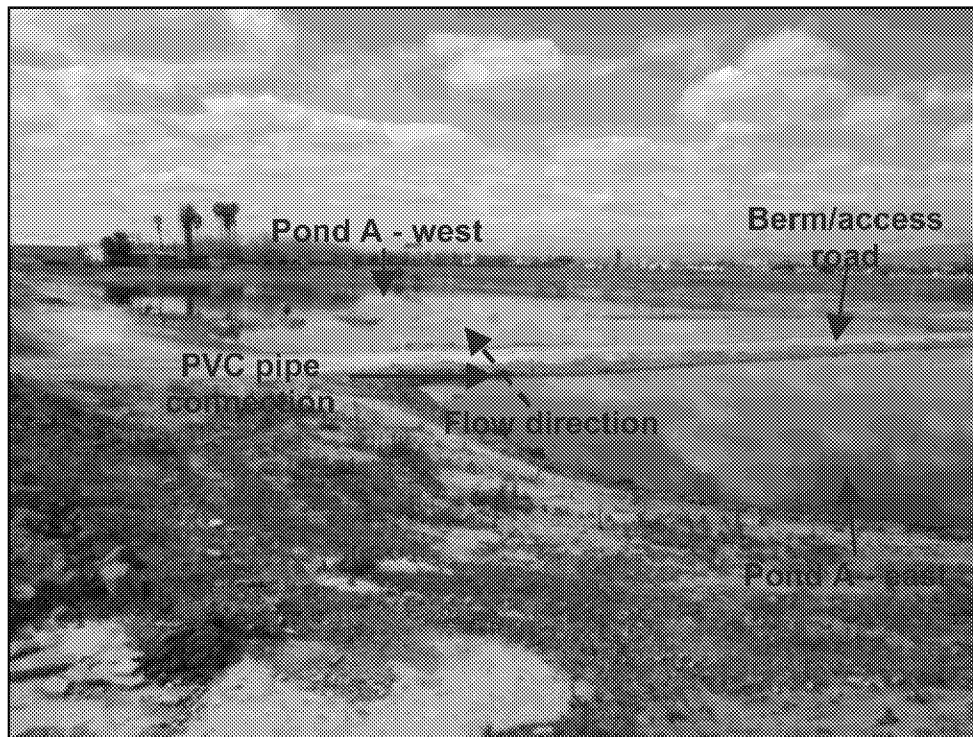
1. The EWMP was not reflective of current Facility conditions at the time of the inspection, and had not been fully implemented onsite at the Facility, as required by Provision VII.C.3.b of the Permit (refer to Photos 7 through 14).

2. The EWMP was not fully implemented onsite at the Facility as required by the Permit. The inspector observed that Pond A had been divided into two sections by a low lying north-south berm/access road on the east side of Pond A which are hydraulically connected via a PVC pipe (refer to Photos 7 through 14). The eastern portion of Pond A is approximately one-quarter the size of the western portion. Mr. Leul stated the separation allows pond solids to settle in the smaller eastern section of the pond during low water times prior to flowing through the PVC pipe and into the larger western section of Pond A. According to Mr. Leul, this consolidates the solids which allows for easier cleaning and removal during the dry season. If the pond water level rises over approximately three (3) feet, water overtops the berm/access road and the two (2) sections of Pond A combine into one (1) pond. The approved EWMP Site Plan does not identify the north-south berm/access road through Pond A; therefore, the berm/access road was potentially reducing the overall capacity of Pond A. As a result, the Discharger was not fully implementing the approved EWMP. The Discharger shall fully implement the EWMP as required by Provision VII.C.3.b of the Permit.

Photograph 7. View facing west of Pond A. Note the pond was divided into two sections by a low lying north-south berm/access road and was hydraulically connected via a PVC pipe on the south side.

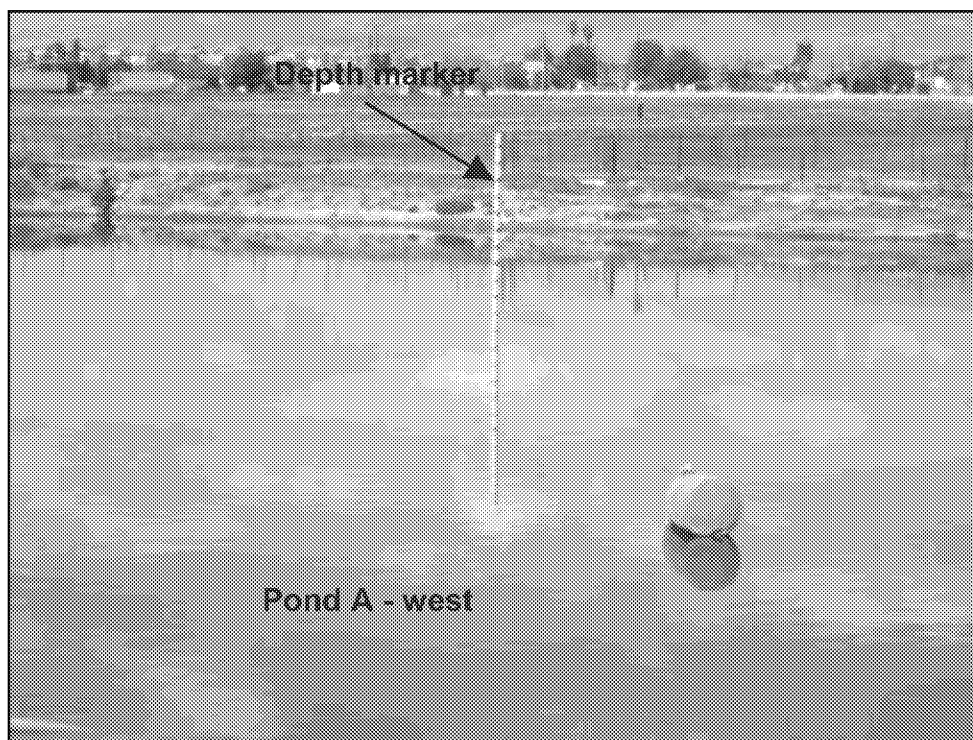
Photograph 8. View facing north of the depth marker located in Pond A.

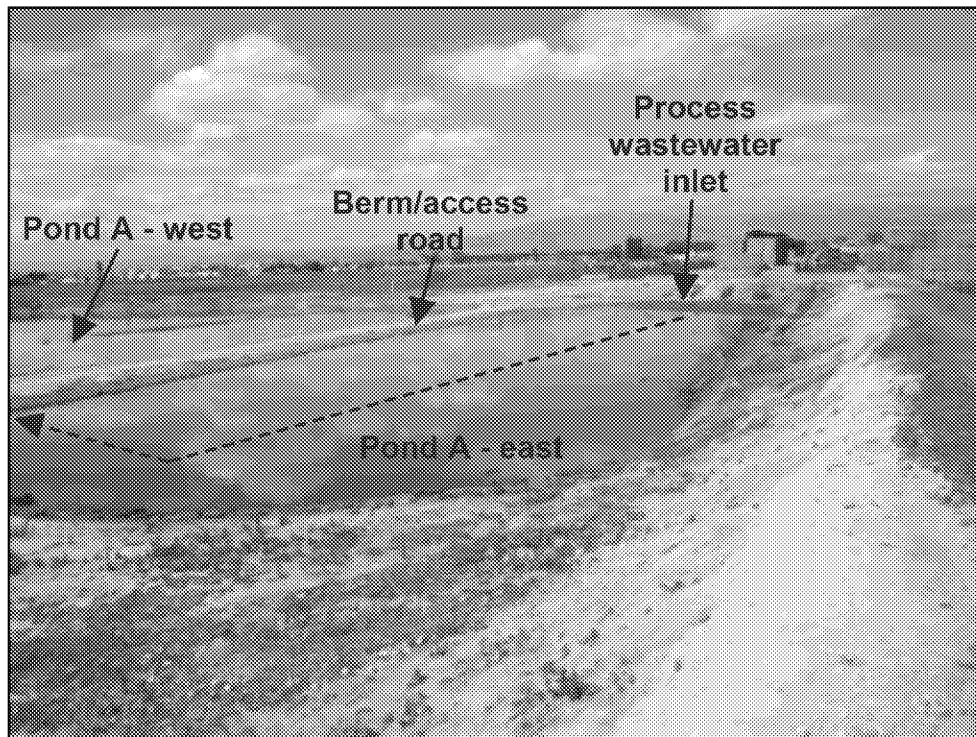
Photograph 9. View facing northwest of Pond A. Note process wastewater enters Pond A in the northeastern portion and eventually flows under the berm/access road via a PVC pipe into the western side of Pond A.

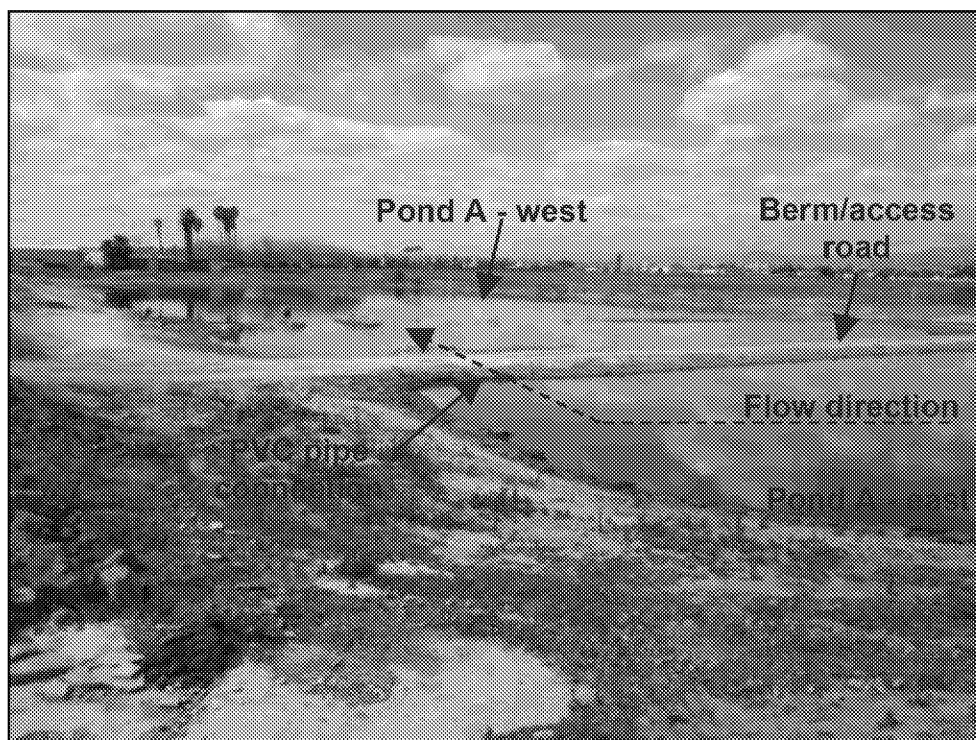
Photograph 10. View facing northwest of the flow direction through Pond A, shown in Photograph 9.

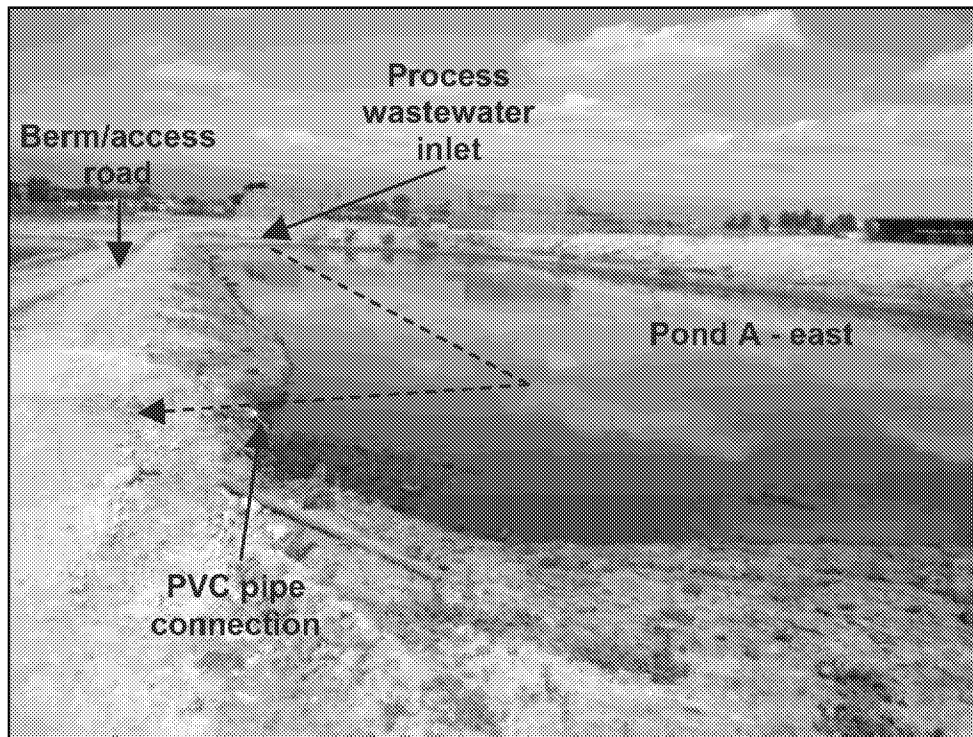
Photograph 11. View facing north of the eastern portion of Pond A. Note the flow pathway from the process wastewater inlet to the western portion of Pond A via a PVC pipe connection.

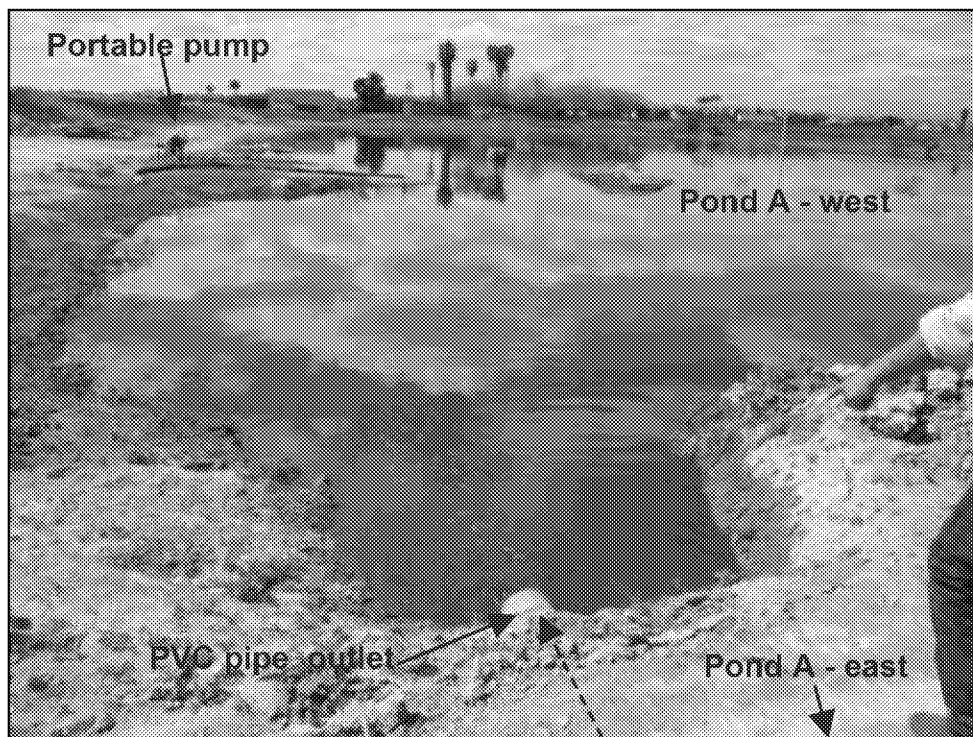
Photograph 12. View facing west of the PVC pipe outlet which drains the eastern portion of Pond A, shown in Photograph 11, into the western portion of Pond A.

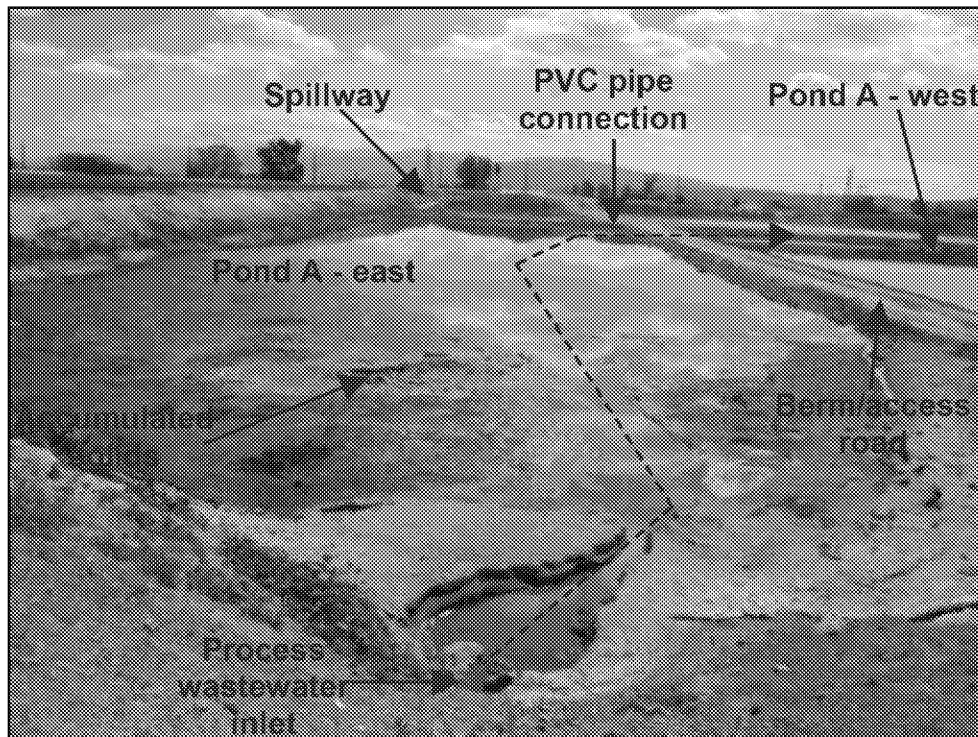
Photograph 13. View facing south of Pond A. Note process wastewater enters the pond in the northeastern portion of the pond and flows west underneath the berm/access road via a PVC pipe connection. Note the majority of solids appear to settle on the east side of Pond A adjacent to the inlet.

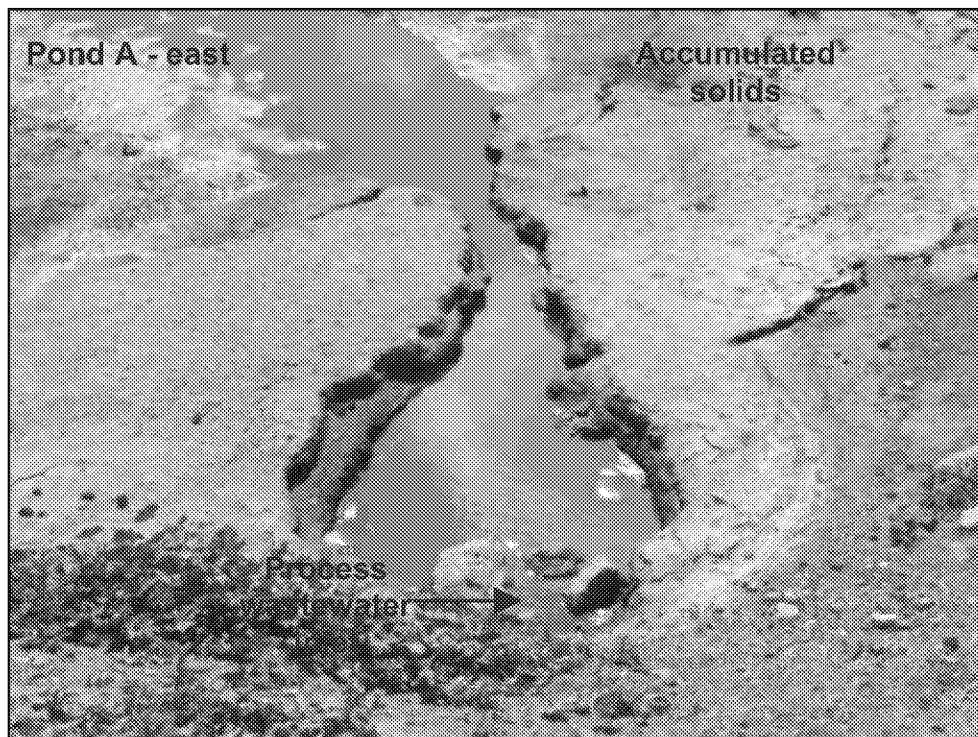
Photograph 14. Close-up view of the process wastewater inlet into the northeastern portion of Pond A, shown in Photograph 13. Note the majority of solids appear to accumulate in the east side of Pond A.

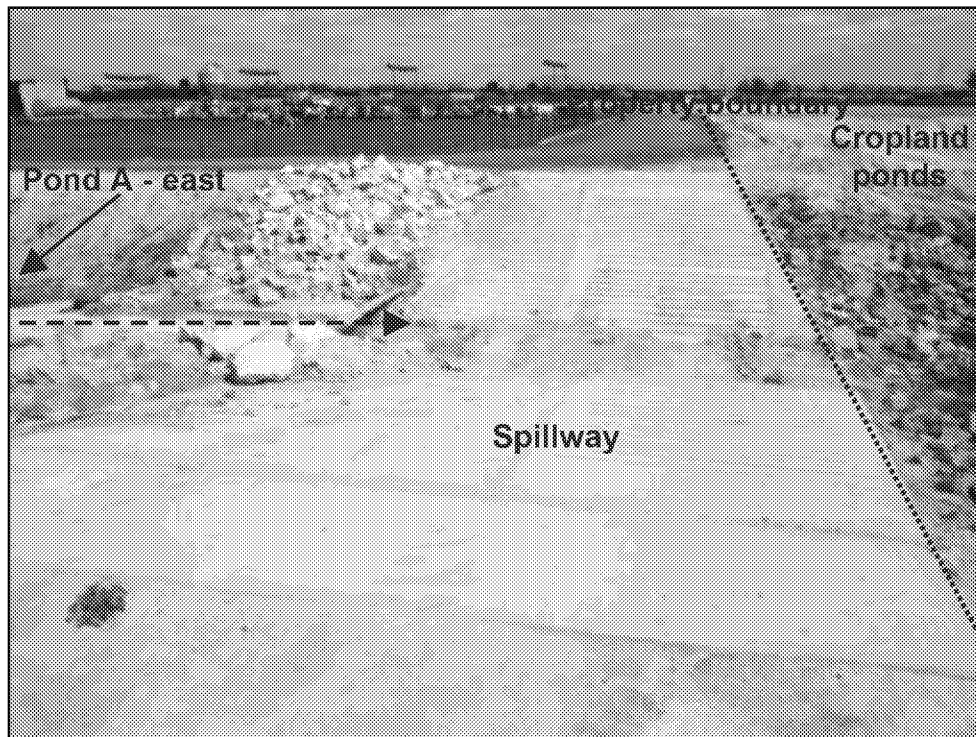
Photograph 15. View facing east of the concrete spillway located in the southeastern corner of Pond A. Note the spillway overflows to a containment pond located on the Discharger's adjacent cropland south of the Facility.

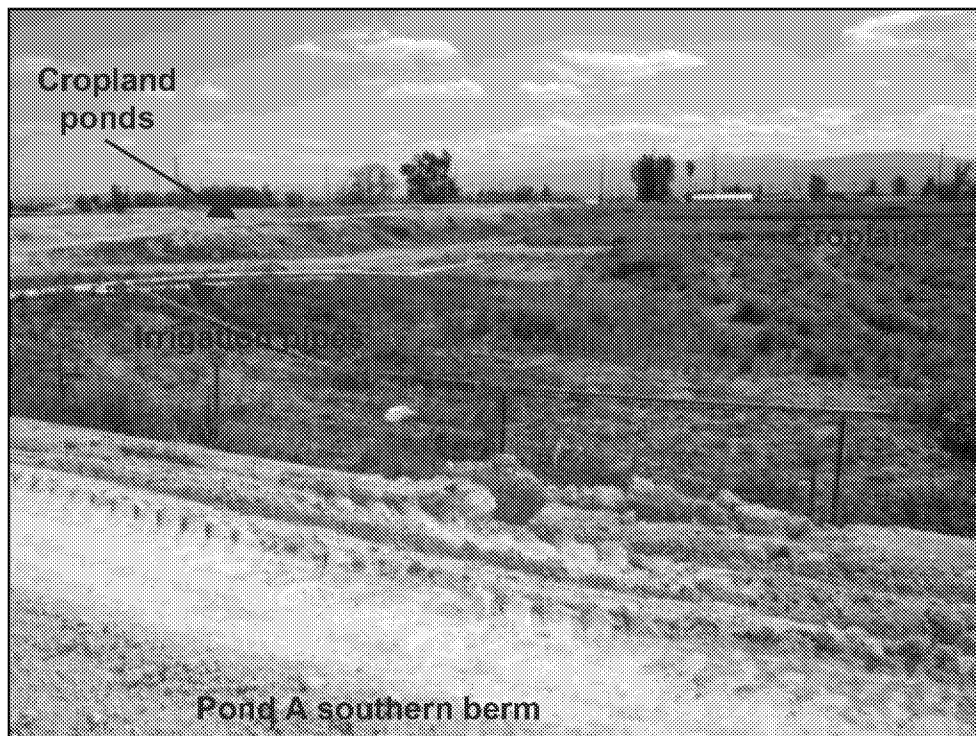
Photograph 16. View facing south of the adjacent cropland south of the Facility. Note this cropland is utilized for feed production at the Facility. Manure and wastewater is land applied here by the Discharger.

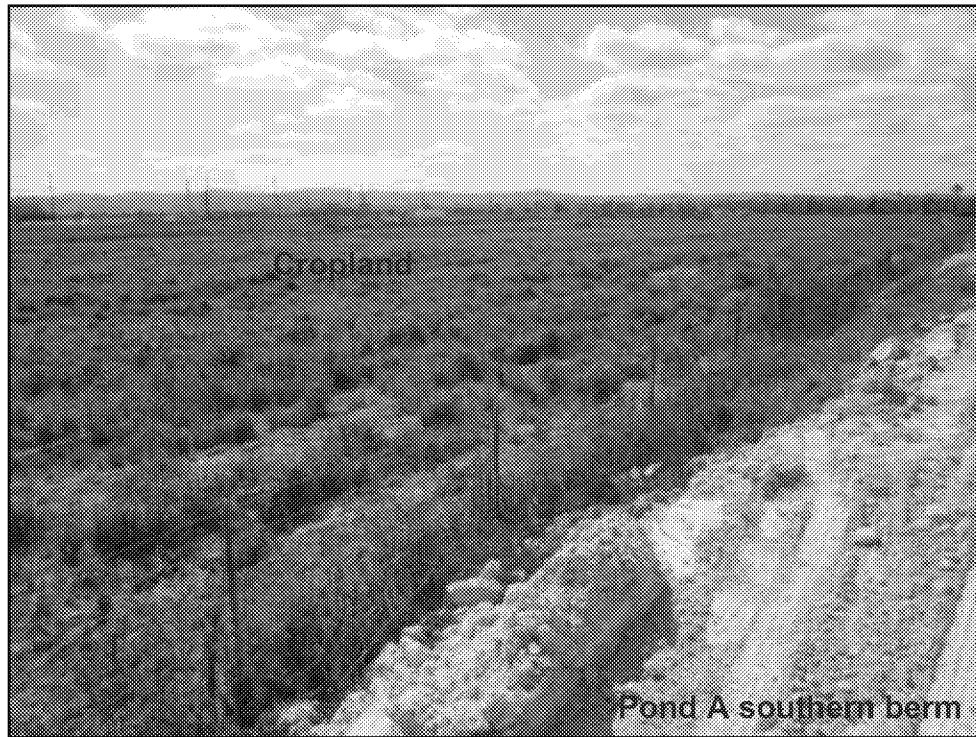
Photograph 17. View facing southwest of the cropland located south of the Facility. Note this cropland is utilized for feed production at the Facility.

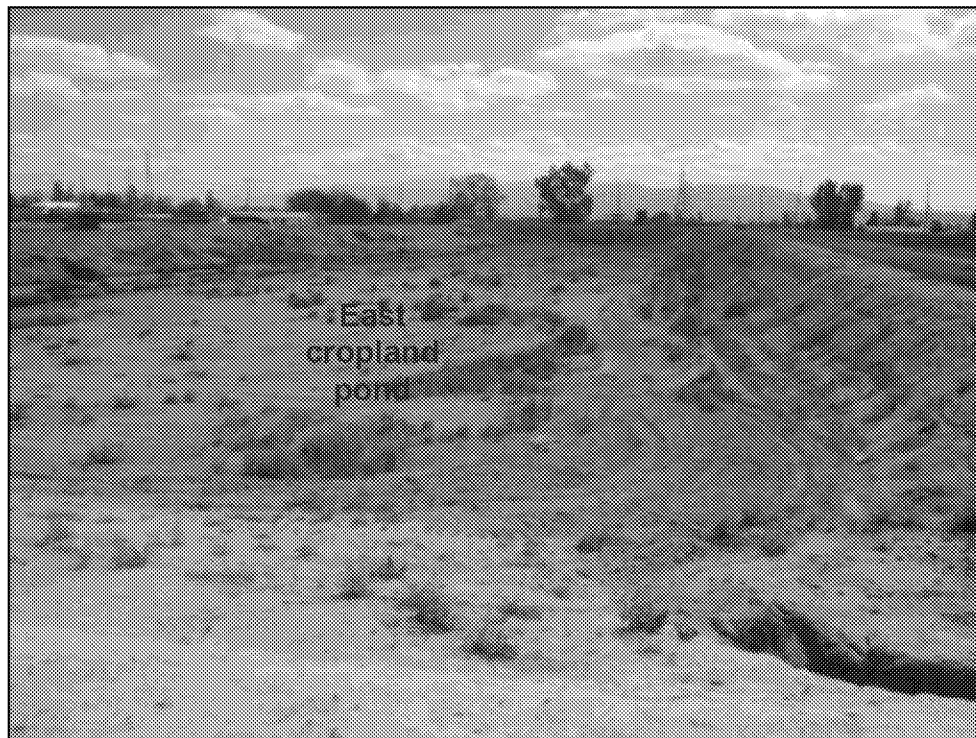
Photograph 18. View facing south of the eastern pond in the northeastern corner of the cropland immediately south of the Facility. Note both ponds were dry at the cropland property.

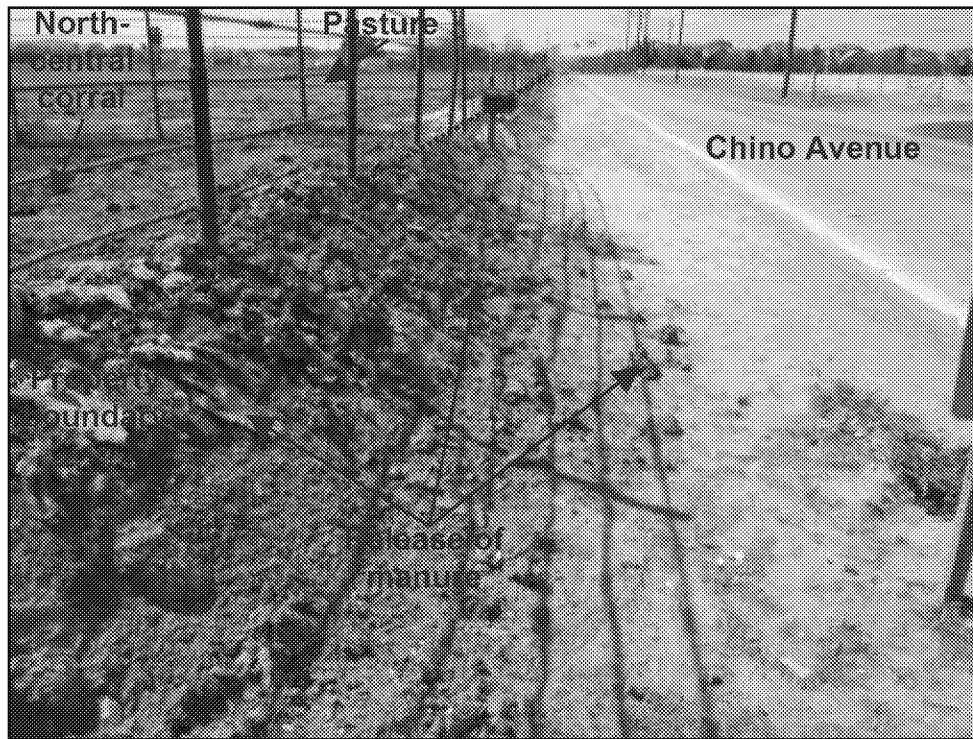
2. A release of manure and process wastewater offsite to the north was observed onto the Chino Avenue right-of-way (refer to Photos 19 through 25). Effluent Limitations V.A.1.a of the Permit states pollutants may be discharged from the Facility if "the production area is designed, constructed, operated, and maintained to contain all manure, litter, and process wastewater including the runoff and the direct precipitation from a 25-year, 24-hour rainfall event." In addition, Discharge Prohibition IV.A states that the "Discharge of process wastewater and/or storm water runoff from manured areas to property not owned or controlled by the discharger, except as authorized by this order, is prohibited." Discharge Prohibition IV.B of the Permit states that a "disposal of manure to land is prohibited."

1. The inspector observed, during the inspection, a release of manure offsite to the north from the north-central corral onto the Chino Avenue right-of-way (refer to Photos 19 and 20). Mr. Leul stated that the release of manure offsite at the north-central corral was common, and that the manure is removed from the right-of-way periodically when the corral is cleaned. The north-central corral was last cleaned in November 2012. Effluent Limitations V.A. 1.a of the Permit states pollutants may be discharged from the Facility if "the production area is designed, constructed, operated, and maintained to contain all manure, litter, and process wastewater including the runoff

and the direct precipitation from a 25-year, 24-hour rainfall event." In addition, Discharge Prohibition IV.B of the Permit states that a "disposal of manure to land is prohibited."

Photograph 19. View facing west of a release of manure offsite from the north-central corral onto the Chino Avenue right-of-way.

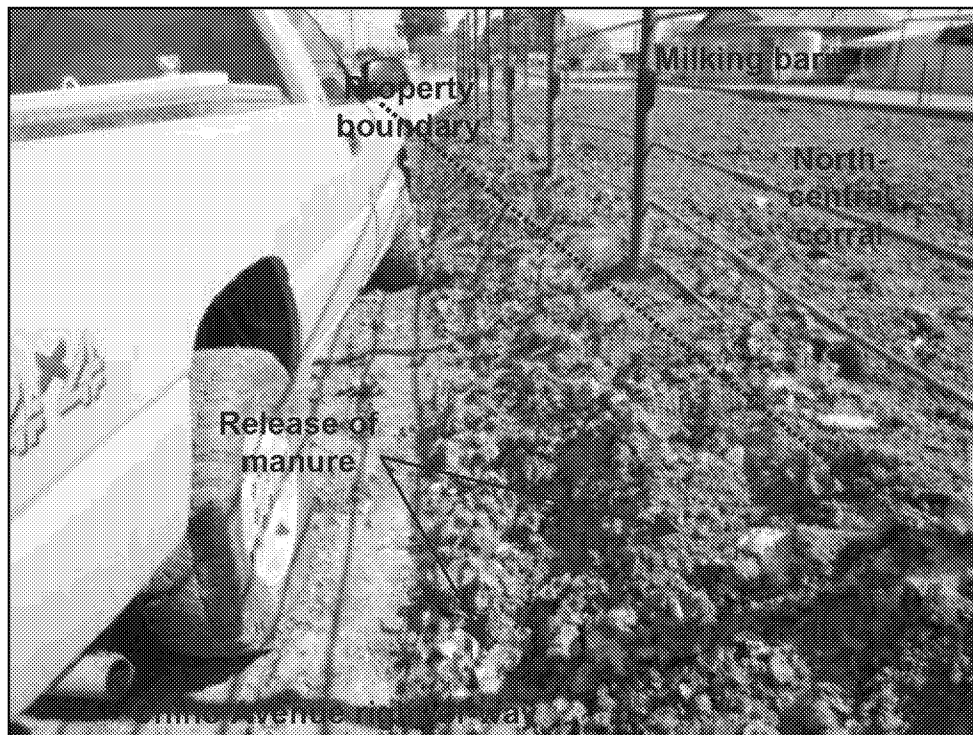
Photograph 20. View facing east of a release of manure offsite from the north-central corral onto the Chino Avenue right-of-way.

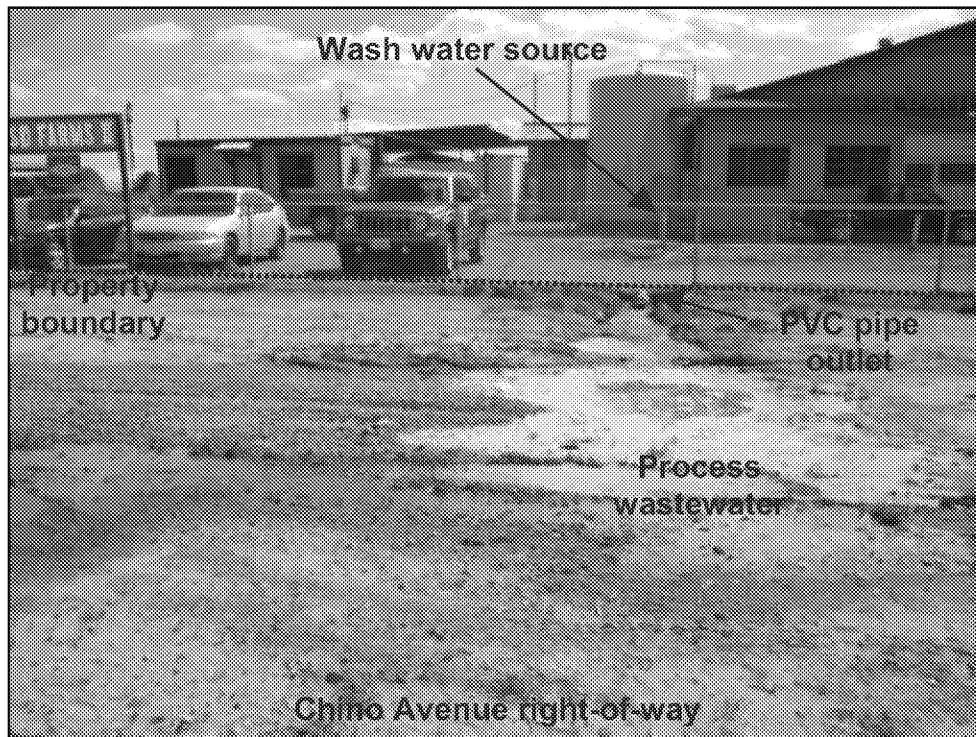
2. The inspector observed, during the inspection, an unidentified source of process wastewater that appeared to have been previously discharged offsite along the northern Facility perimeter onto the Chino Avenue right-of-way (refer to Photos 21 through 25). In addition, a PVC pipe leading from the Facility onto the Chino Avenue right-of-way was identified adjacent to the offsite ponding process wastewater. Mr. Leul stated that the process wastewater was a combination of milk truck wash water from a water spout on the north side of the milking barn and a previous overflow of irrigation water from an adjacent farmland on the north side of Chino Avenue. Mr. Leul was unaware of the PVC pipe outlet or the actual source at the time of the inspection. The inspector was unable to locate the inlet of the PVC pipe. The process wastewater observed on the Chino Avenue right-of-way appeared to have been discharged from the Facility, as no other water was observed along Chino Avenue. Discharge Prohibition IV.A states that the "Discharge of process wastewater and/or storm water runoff from manured areas to property not owned or controlled by the discharger, except as authorized by this order, is prohibited."

Photograph 21. View facing south of a discharge of process wastewater offsite onto the Chino Avenue right-of-way. Note the PVC pipe drain leading from the Facility wash bay onto the right-of-way. Facility staff stated the water was a combination of truck wash water and an adjacent farmland irrigation water discharge.

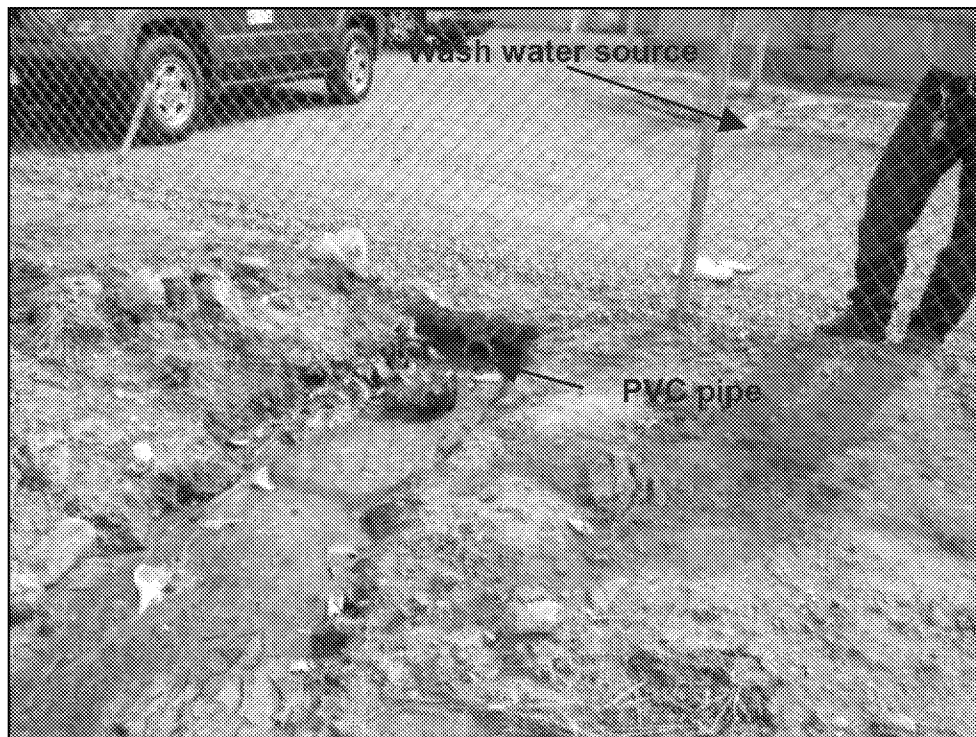
Photograph 22. Close-up view of the PVC pipe shown in Photograph 21.

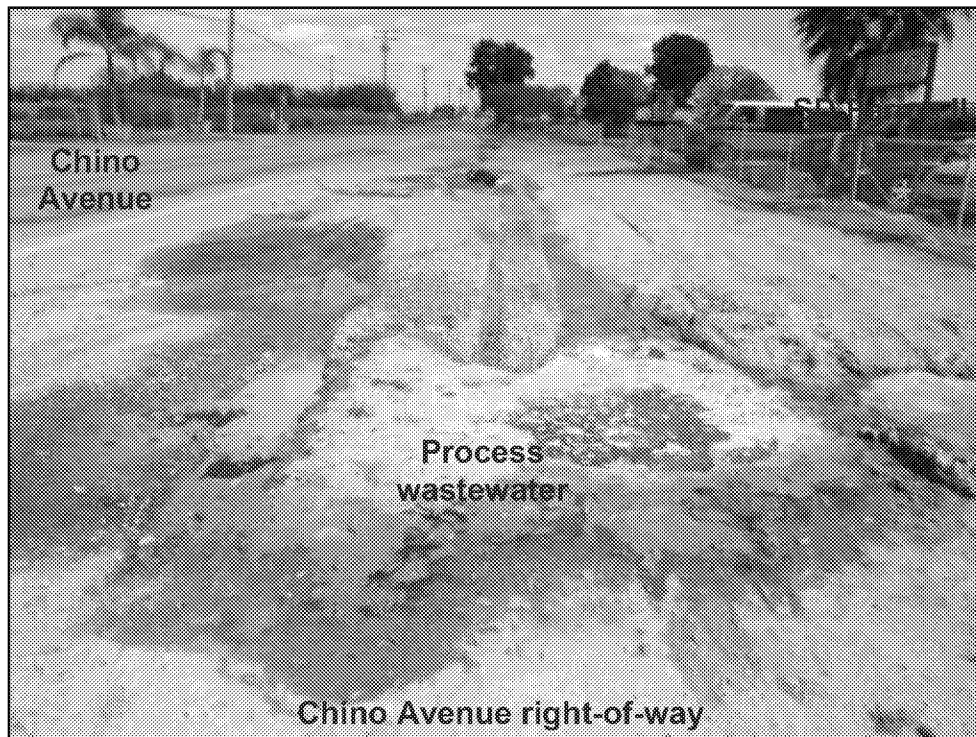
Photograph 23. View facing east of the discharge of process wastewater offsite onto the Chino Avenue right-of-way. Note Facility staff stated the water was a combination of Facility truck wash water and an adjacent farm irrigation water discharge, on the north side of Chino Avenue.

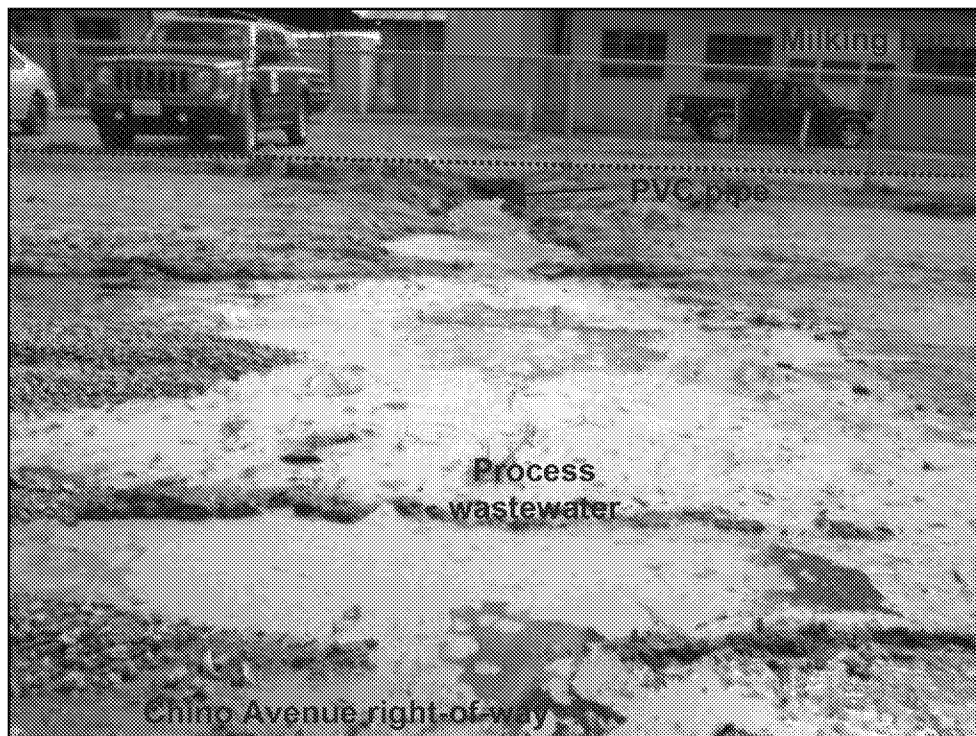
Photograph 24. View facing south of a discharge of process wastewater offsite onto the Chino Avenue right-of-way. Note the PVC pipe leading from the Facility, shown in Photographs 21 and 22.

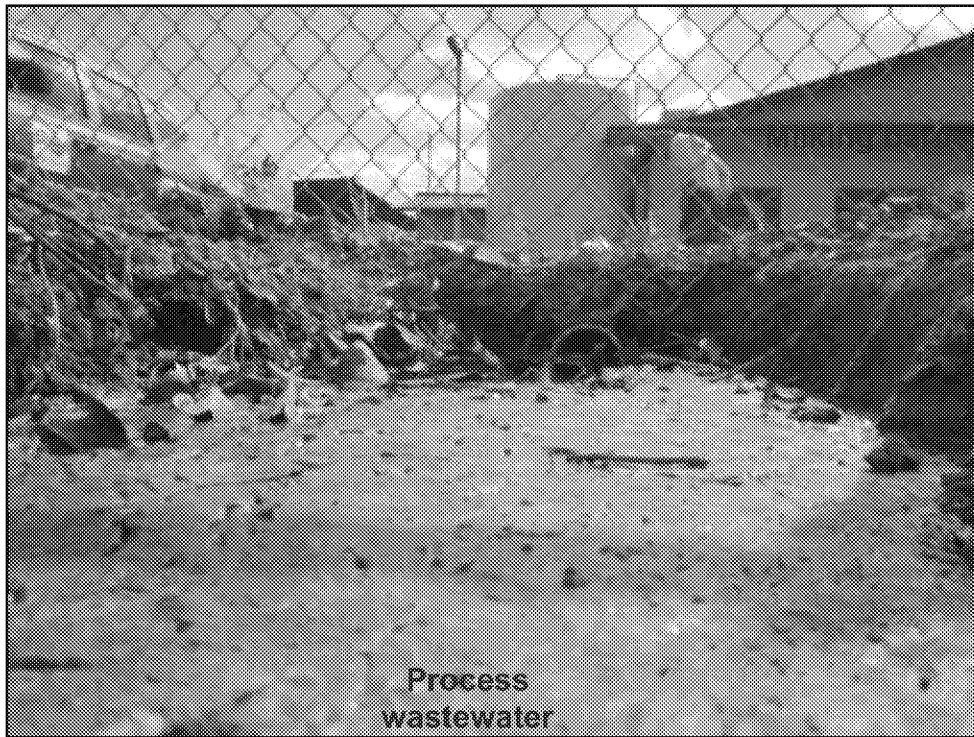
Photograph 25. Close-up view facing south of the PVC pipe leading from the Facility, shown in Photographs 21, 22, and 24.
